OUT-OF-PLANE TESTING OF UNREINFORCED BRICK INFILL WALLS WITHIN STRUCTURAL FRAMES

AUCKLAND CBD, ORAKEI,
HASTINGS, AND
WELLINGTON,
NEW ZEALAND

Final Report – LR0441

Submitted to BRANZ 30 June 2014

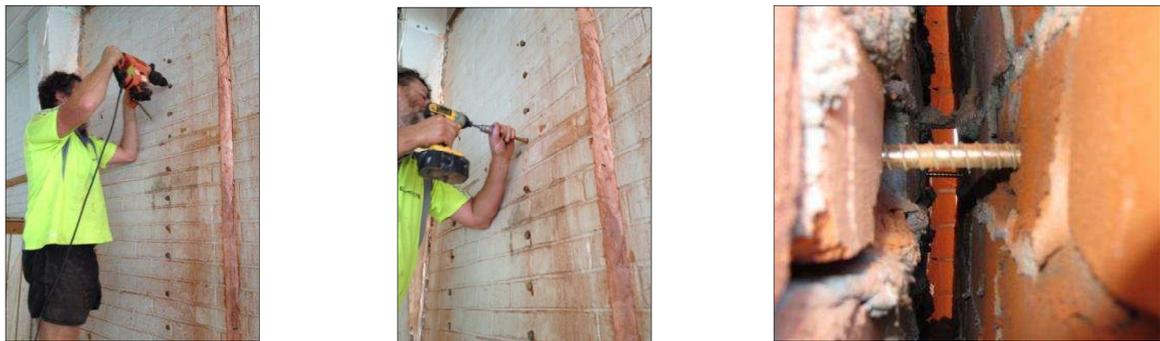
Figure 8: Installing procedure for cavity restraint ties

(a) Pre-drilling cavity tie holes (b) Installing mechanical ties (c) Mechanical tie spanning cavity

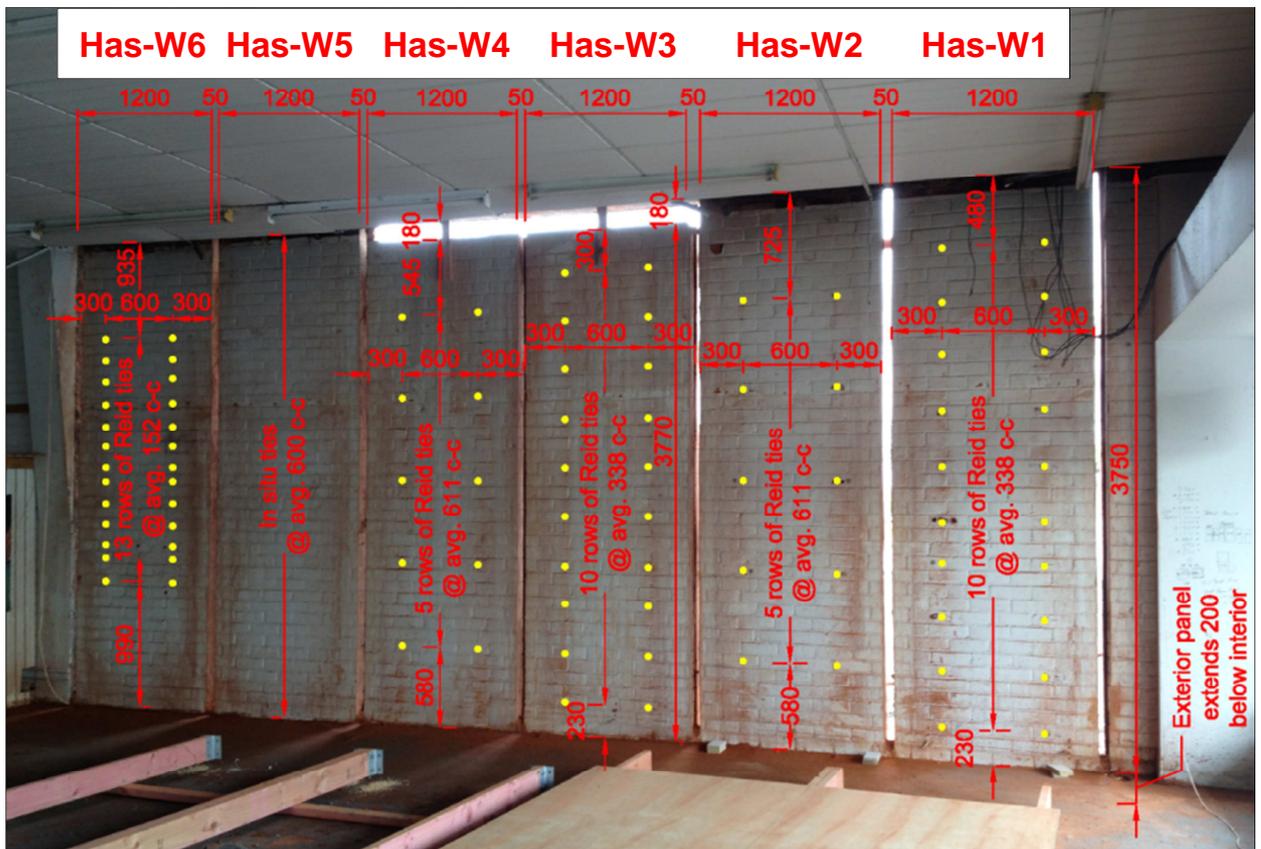
Figure 9: Dimensions of test walls at the Hastings building and spacing of mechanical cavity ties

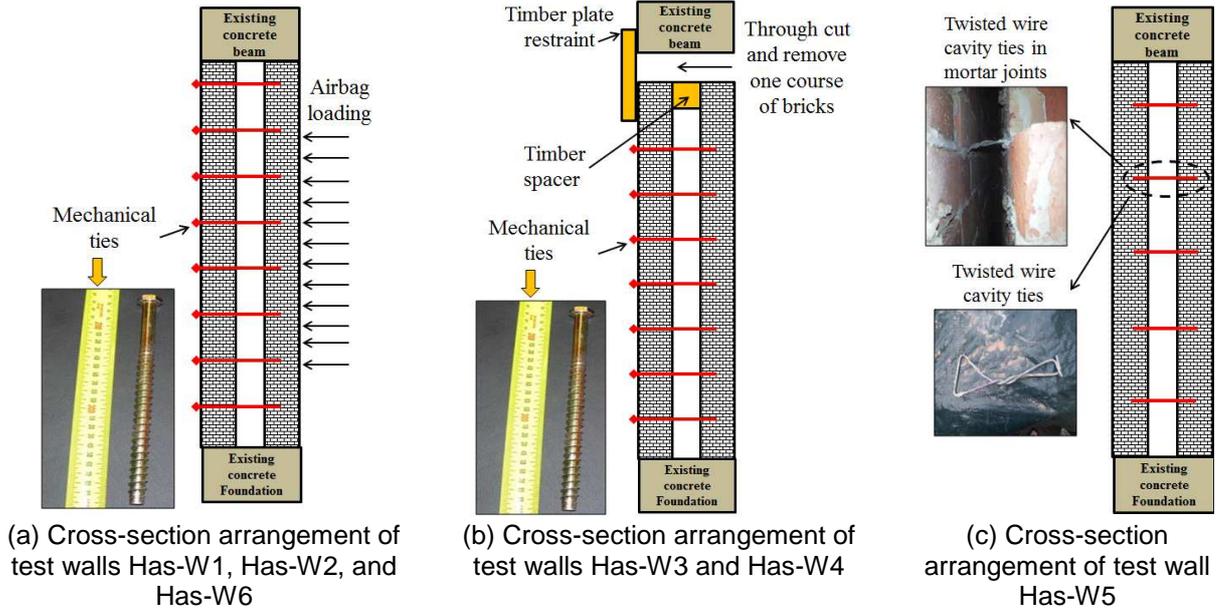
Figure 10: Test wall preparation of walls in the Hastings building in one-way flexure

Preparation of all walls in the Hastings building was performed by cutting through both leaves of the wall at such spacing as to produce six 1200 mm wide by 3750 mm tall sections of two-leaf masonry cavity walls separated from one another by approximately 50 mm and with in situ cavity reinforcing ties intact. All walls were tested with in situ ties left in place. Test wall Has-W5 was tested with only in situ ties, while all other test walls were retrofitted with 12 mm diameter by 230 mm long mechanical ties at different vertical spacings (see **Figure 8** and **Figure 9**). The top few rows of bricks were removed in test walls Has-W3 and Has-W4 and replaced with a timber support restraining horizontal translation while permitting rotation. This arrangement of boundary conditions more closely approximates URM partition walls that extend into timber-framed roofs (such as those on the fourth floor of the WRS building). All other walls were tested with the tops of the walls in their in situ condition, fixed by the RC beam above (see **Figure 10**).

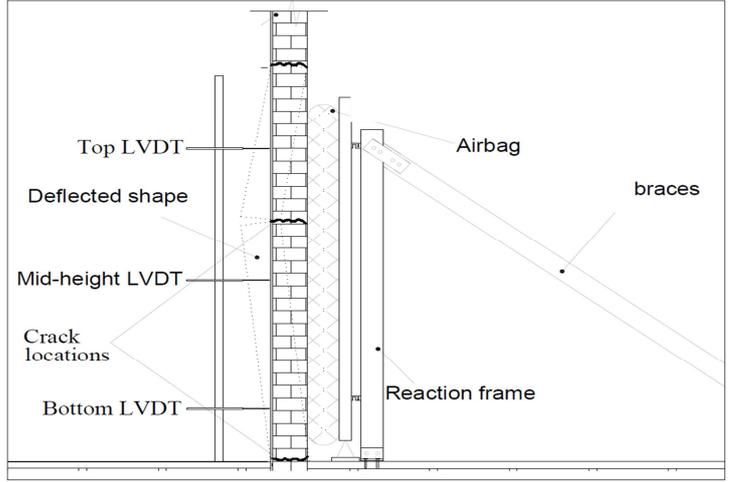
(e) Schematic of OOP test bracing (right of wall cross-section) and displacement instrumentation (left of wall cross-section)

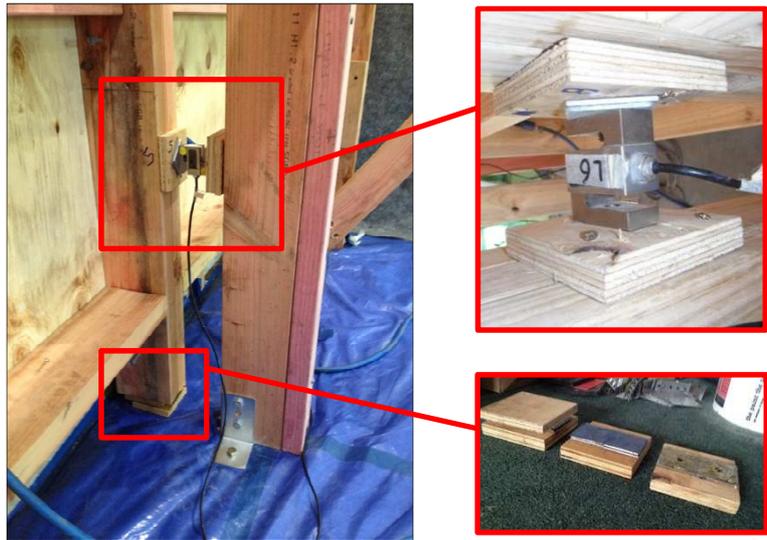
(g) Close-up of base of reaction frame with s-shaped load cell placed between the plywood-backed panel frame and the braced reaction frame (top), and the plywood-backed frame sitting atop greased steel low-friction plates and loose plywood pieces

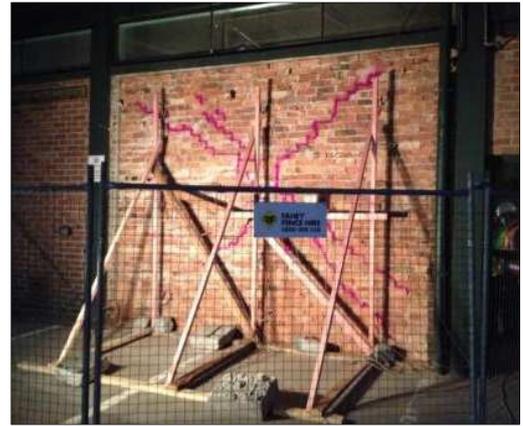
(c) Displacement instrumentation frame for long-wall with cracks from OOP two-way flexure highlighted

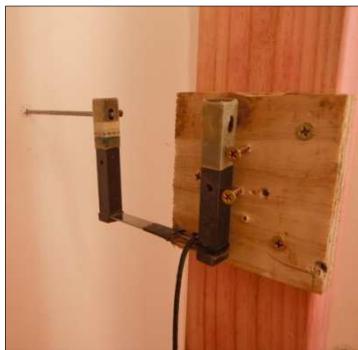
(d) Strain or "portal" gauge spanning between the test wall and the isolated instrumentation frame

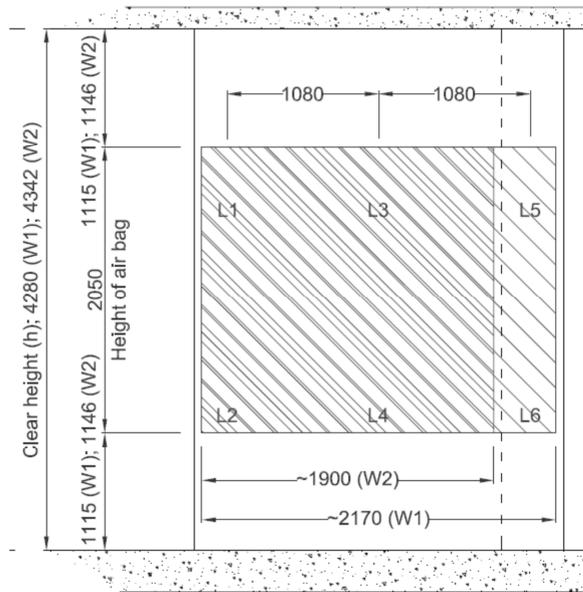
(c) Example of test wall elevation showing the positions of the load cells, loaded area and the position of the saw cuts (mm) for Wel-W1 and Wel-W2 only (Note: Dashed line indicates saw cut for Wel-W2B relative to load frame)

Six distinct test walls were tested a total of seven times at the Wellington Railway Station. Examples of the test setup and instrumentation from the Wellington Railway Station are shown in **Figure 16**. The instrumentation layout is documented graphically in **Figure 17** (wherein G = strain gauge, S = string potentiometer, and L = load cell). Numerical values associated with the symbols used in **Figure 17** are included in **Table 2** and **Table 3**.

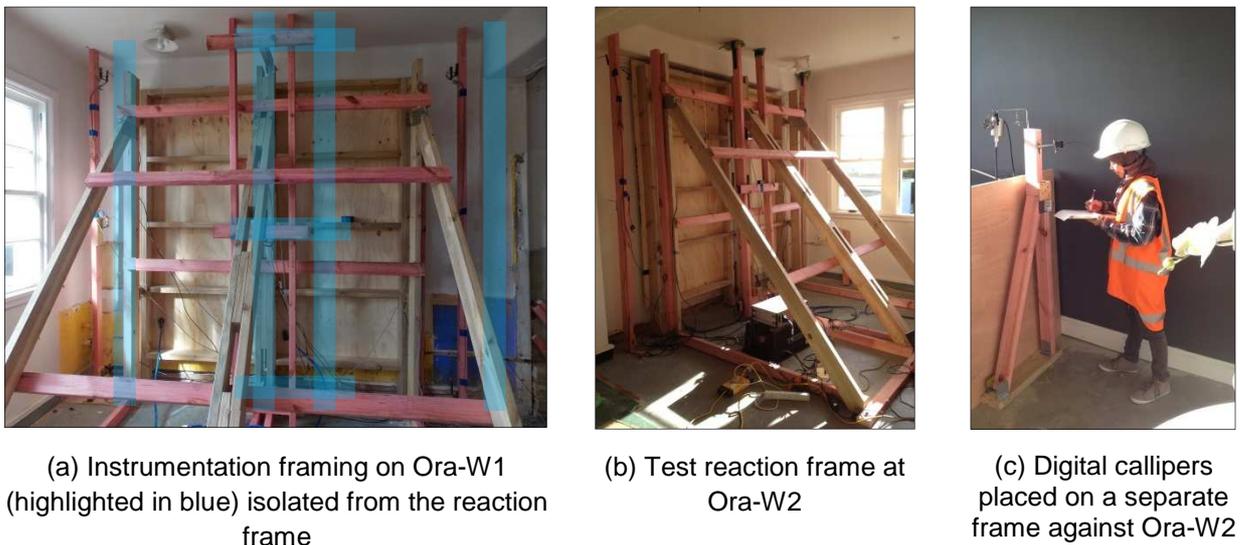
Figure 18: Examples of the test setup and instrumentation at the Orakei building

Two distinct walls were tested at the Orakei building. Unlike walls at any of the other buildings, OOP displacement of the tested walls at the Orakei building was measured using portal gauges and string potentiometers placed on the same side of the test walls as the reaction frame (due to restrictions on accessibility to the unloaded side of the test walls), but on separate, isolated frames so as to not be affected by deformations within the loading frame. Where the backside of test wall Ora-W2 was accessible for a short duration during testing, digital callipers were placed on a separate frame to supplement the measurements being taken by instrumentation on the loading side. Examples of the test setup and instrumentation from the Orakei building are shown in **Figure 18**. The instrumentation frame (placed on the same side of the test walls as the loading frame) supported as many as eight strain gauges and two string potentiometers simultaneously. The instrumentation layout is documented graphically in **Figure 19** (wherein G = strain gauge and S = string potentiometer). Values associated with the symbols used in **Figure 19** are included in **Table 4** and **Table 5**. The digital callipers placed on the opposite side of test wall Ora-W2 were located at approximately mid-height and mid-length of the wall (i.e., mirrored location relative to instrument S1).

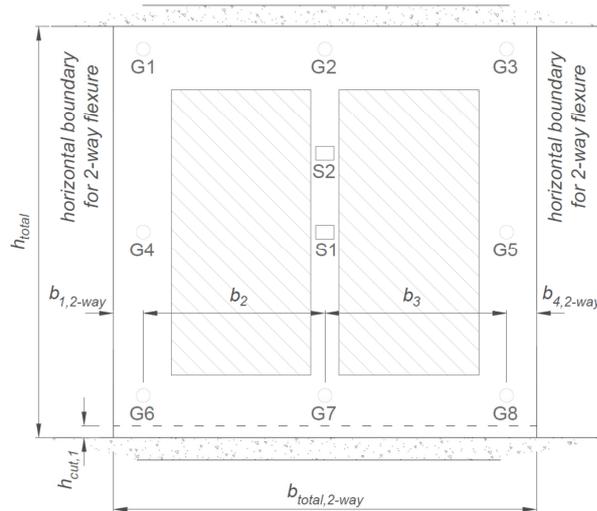
(c) Test wall elevation for W1 and W2 (reference **Table 4** and **Table 5**) [Note: dashed line indicates saw cut; hatched area indicates loaded area from airbags approximately 1150 x 2050 mm each]

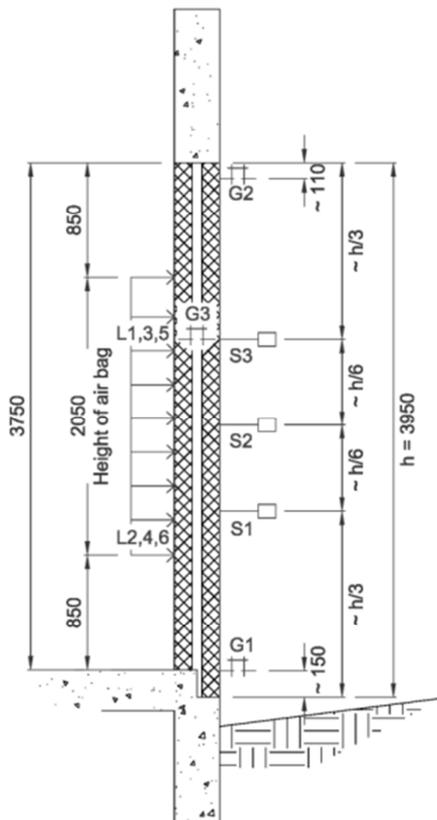
(a) Test wall cross-section showing location of displacement gauges for test walls Has-W1, Has-W2, Has-W5, and Has-W6

Six distinct test wall panels (all cut from within the same larger wall panel) were tested at the Hastings building. The same, unaltered reaction frame and instrumentation frame were used for testing all of the walls in one-way flexure. Examples of the test setup and instrumentation from the Hastings building are shown in **Figure 20**. The instrumentation layout is documented graphically in **Figure 21** (wherein G = strain gauge and S = string potentiometer).

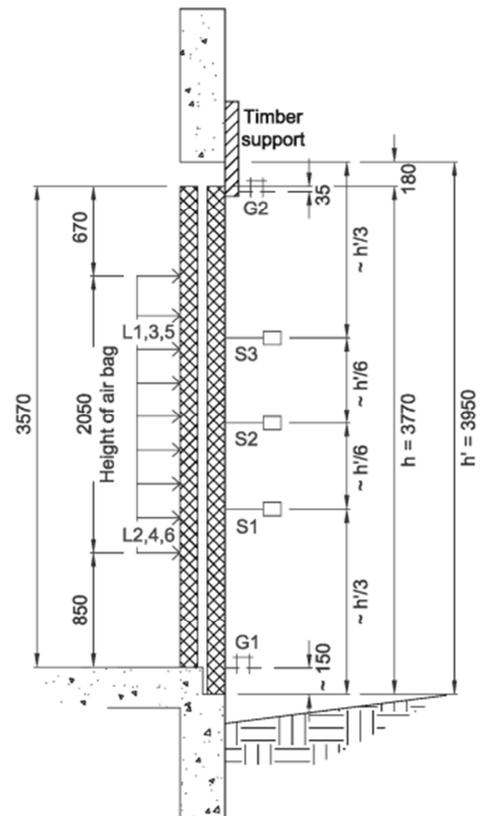
Test wall cross-section showing location of displacement gauges for test walls Has-W3 and Has-W4

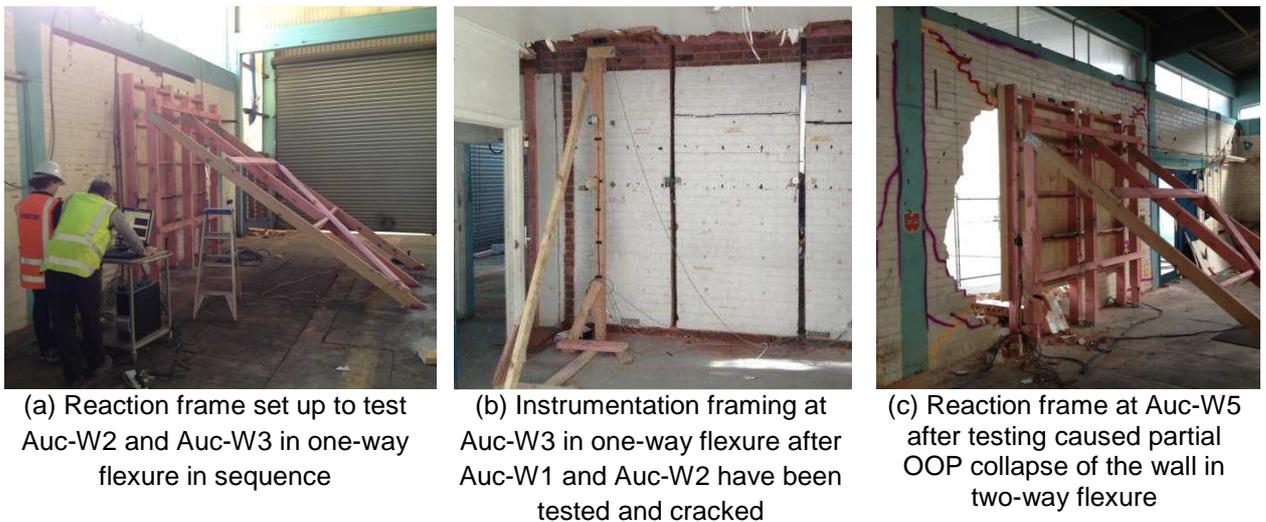
Figure 22: Examples of the test setup and instrumentation at the Auckland building

Five distinct test wall panels (three cut from within the same larger wall panel) were tested a total of six times at the Auckland building. Examples of the test setup and instrumentation from the Auckland building are shown in **Figure 22**. Auc-W1, Auc-W2, and Auc-W3 were instrumented with a frame consisting of a single vertical post with two string pots located at 1500 mm and 2100 mm above the floor and a single steel portal gauge located 3000 mm above the floor. The same instrumentation frame was used for testing of all three one-way flexure walls. Auc-W4 and Auc-W5 required a much longer instrumentation frame [see **Figure 15(c)**]. The instrumentation frame for test walls Auc-W4 and Auc-W5 held in place twelve portal gauges and one string pot to measure the OOP displacement of the walls. The instrumentation layouts for all test walls in the Auckland building are documented graphically in **Figure 23** (wherein G = strain gauge, S = string potentiometer, and L = load cell).

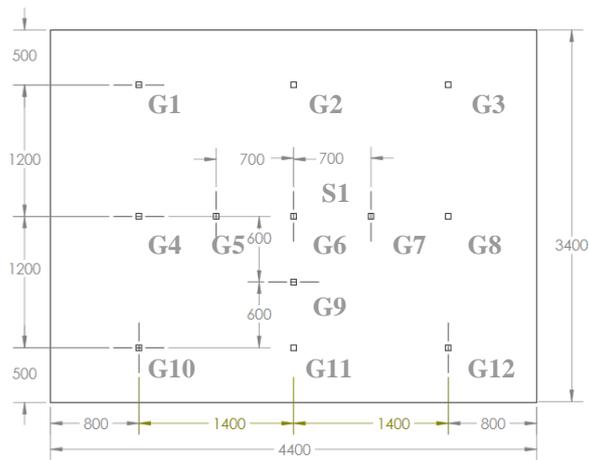
(d) Auc-W4 and Auc-W5 displacement instrumentation

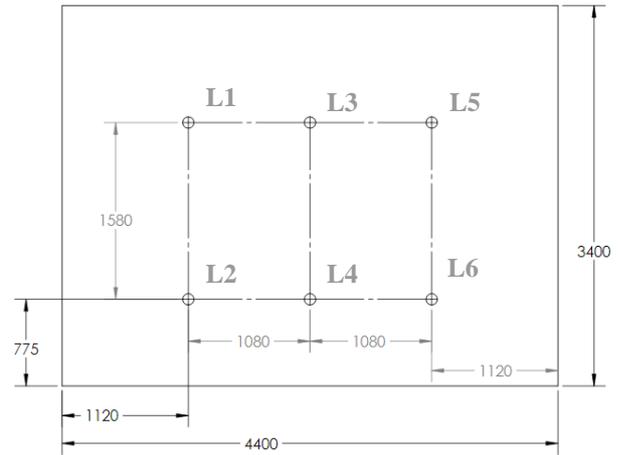
(e) Auc-W4 and Auc-W5 load cell placement

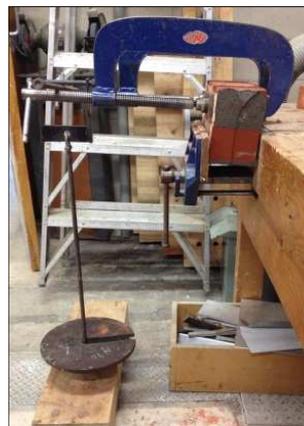
(e) Typical bond rupture test setup

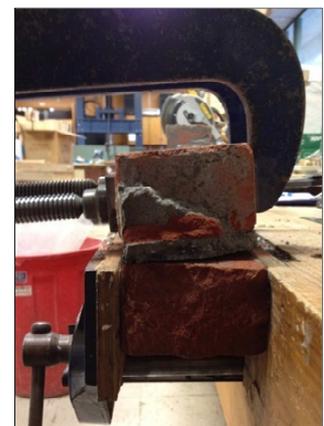
(f) Bond rupture at interface of brick and mortar

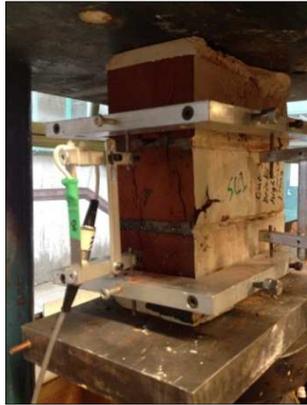
(g) Typical stacked masonry prism compression test setup with four portal gauges used to measure stiffness

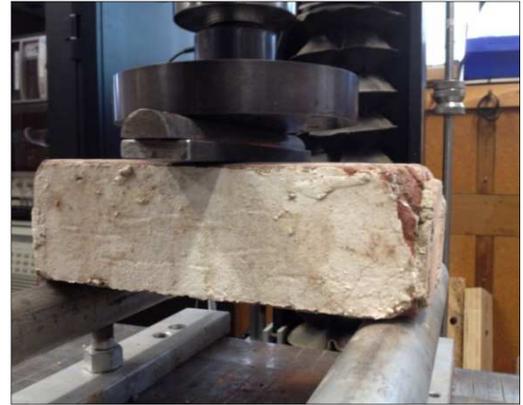
(h) Typical brick rupture test setup

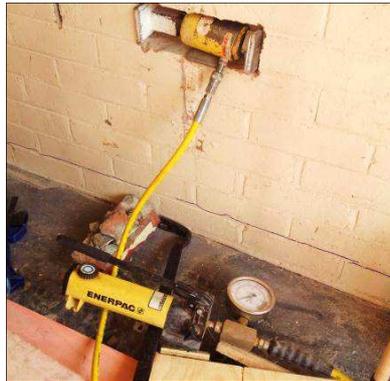
(a) Mortar bed joint shear test setup on Wel-W1

In situ mortar bed joint shear tests were conducted in accordance with ASTM C1531-03, and the test setup is exemplified **Figure 25**. This type of test is moderately destructive as it requires the removal of at least one brick on one side of the test specimen to allow for insertion of a hydraulic jack, as well as the removal of a vertical mortar joint on the opposite side to allow horizontal bed joint movement to occur. The hydraulic jack was loaded using a pressure controlled hydraulic pump until visible bed joint sliding failure occurred. The bed joint shear strength was derived from the peak pressure records.

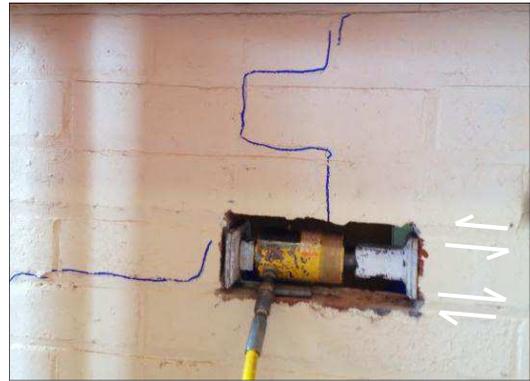
(b) Mortar bed joint shear test setup on Wel-W2 with cracks propagating from load highlighted in blue

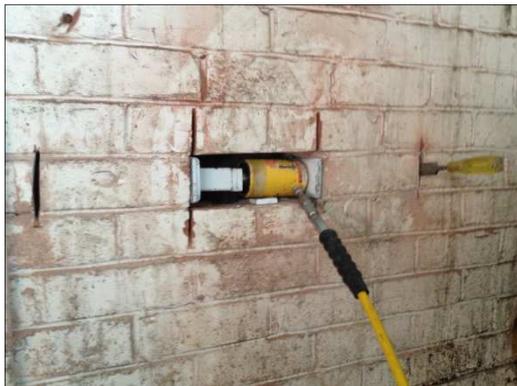
(c) Mortar bed joint shear test setup on Auc-X1 (on otherwise untested wall)

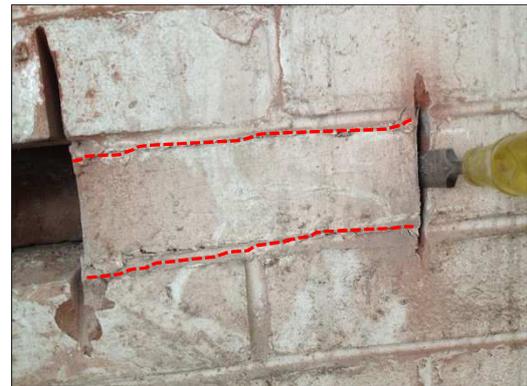
(d) Mortar bed joint shear damage from testing on Auc-X1 (an otherwise untested wall) with shear cracks highlighted in red

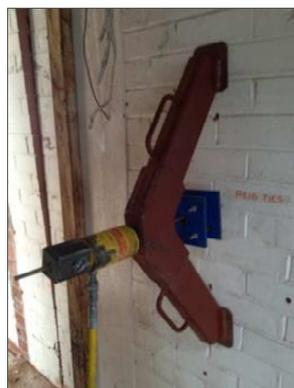
(a) Brace, load cell, and attachment used to pull out cavity tie from brick wall

The cavity ties used to retrofit test walls Auc-W1B, Auc-W2, and Auc-W3 were also tested in isolated pull-out tests, using the test set-up that is illustrated in **Figure 26**. The results are summarised in **Table 8**. Note that the 12 mm diameter mechanical tie type, which permitted test wall Auc-W1B to outperform its counterparts, also was found to have the highest isolated pull-out strength. However, cavity tie pull-out was not observed to limit the test wall capacities.

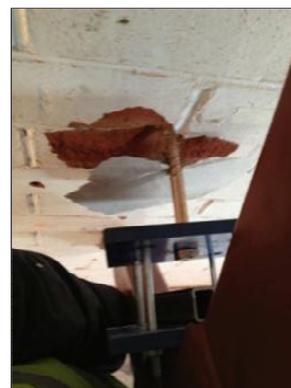
(b) Pull-out failure due to brick conical shear

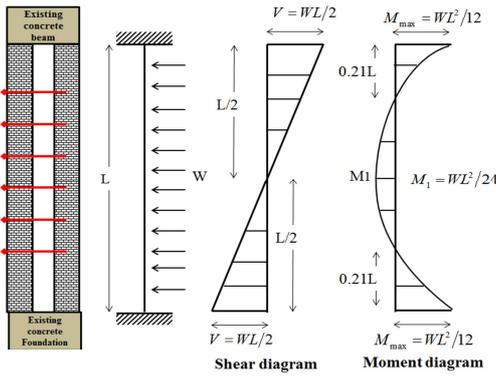
(a) Assumed shear and moment response of walls fixed at both the top and bottom

All tests walls listed in **Table 1** other than Ora-W1 and Ora-W2 rested on RC slab and were, therefore, presumed to be restrained laterally, axially, and rotationally along the bottom edge (i.e., restrained by a “fixed” support). Walls noted in **Table 1** as having a top edge restraint consisting of an RC slab or beam were also assumed to be restrained laterally, axially, and rotationally at the top edge as well (i.e., “fixed”). Walls noted in **Table 1** as having a top edge restraint consisting of timber were assumed to be restrained laterally but neither axially nor rotationally (i.e., restrained by a “propped” support). The shear and flexural implications of the two scenarios, at least in regard to “vertical” flexure, are illustrated in **Figure 27(a)** and **(b)**.

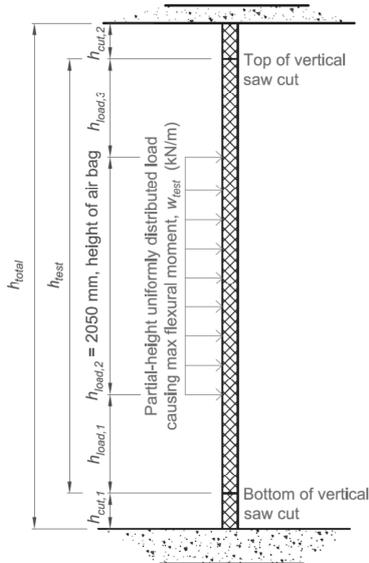
(c) Actual test condition for fixed-fixed wall

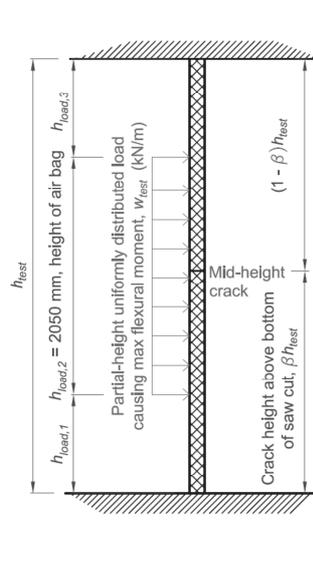
(d) Assessed condition for fixed-fixed wall with test height and partial-height uniform loading

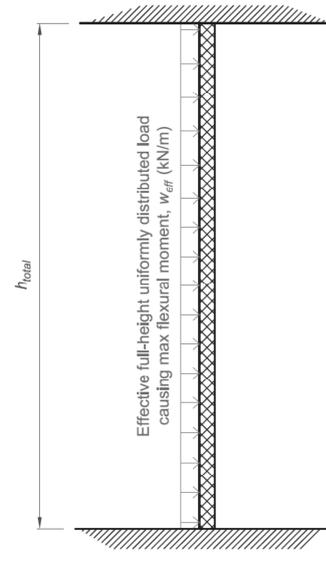
(e) Assessed "effective" condition for fixed-fixed wall with in situ full height and full-height uniform loading

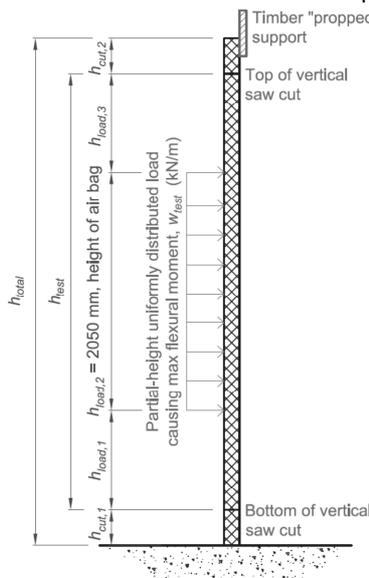
(f) Actual test condition for fixed-propped wall

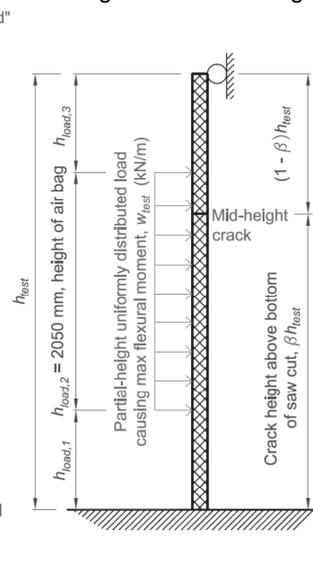
(g) Assessed condition for fixed-propped wall with test height and partial-height uniform loading

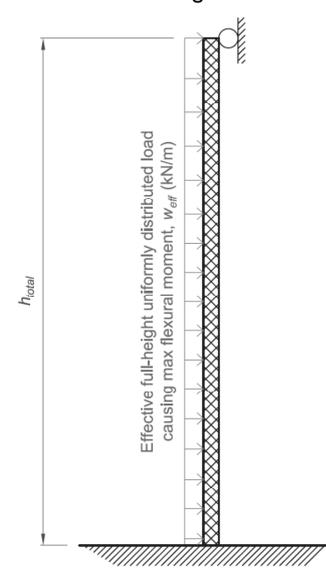
(h) Assessed "effective" condition for fixed-propped wall with in situ full height and full-height uniform loading

This flexural capacity, $M(\beta h_{test})$, is then presumed to represent the mid-height flexural capacity in the full-height scenario [see **Figure 27(b)** and **(h)**], such that the effective uniformly distributed load, w_{eff} , can be derived. Note that all walls that were tested in a fixed-propped condition (in some cases, by removing the top few rows of bricks from beneath the RC beam above and introducing a timber restraint) were assessed as if their in situ condition was fixed-propped regardless of the actual in situ condition, such that the effect of the different restraint conditions could be considered. Such conversions of measured test capacities to effective full-height capacities were not performed for walls tested in two-way flexure. Because all walls tested in two-way flexure were tested in their full-height condition with loading concentrated near the centre of each wall, the horizontal seismic acceleration capacities (g) presented in **Section 5.2.4** are assumed to be slightly conservative.

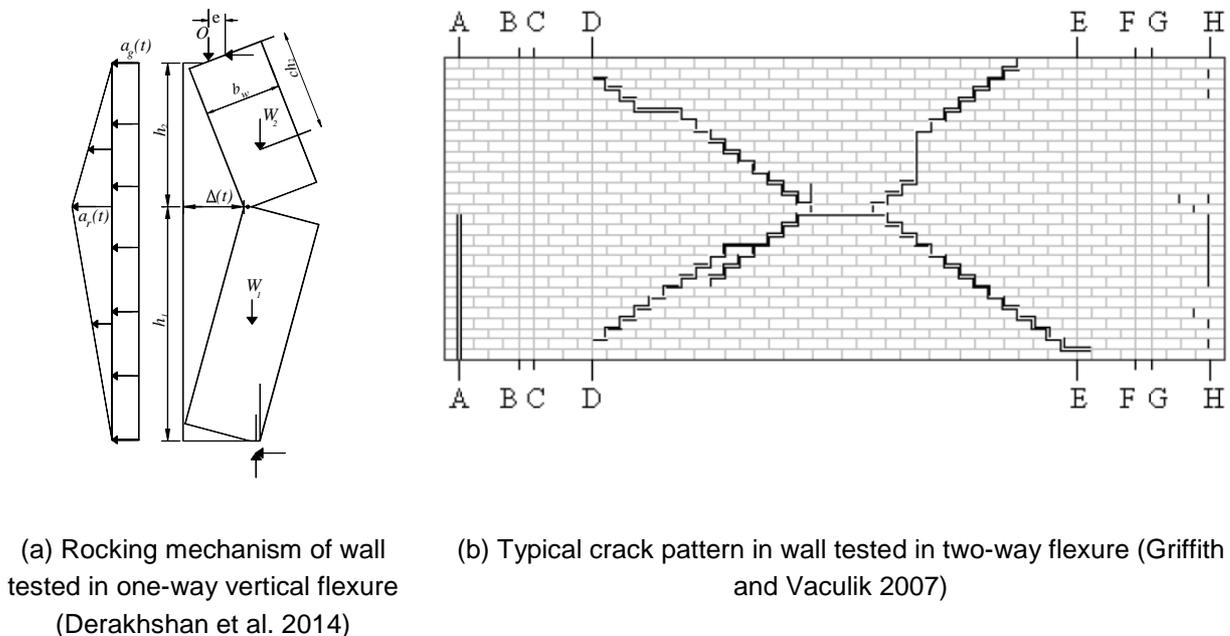
Figure 28: Typical damage mechanisms for URM walls subjected to OOP loading

A virtual work-based, two-way flexural analysis, which includes weighted components of horizontal flexure (i.e., flexure about a vertical axis) and diagonal flexure [see **Figure 28(b)**], can be conducted by implementing the design procedure of AS 3700:2011 and Think Brick Australia (2013). In practise, walls may be assessed considering both vertical flexure and two-way flexure. The capacity limit state with the higher value between vertical flexure and two-way flexure may be presumed to govern for any specific wall panel given the inherent conservativeness in the idealised failure modes presumed by each method.

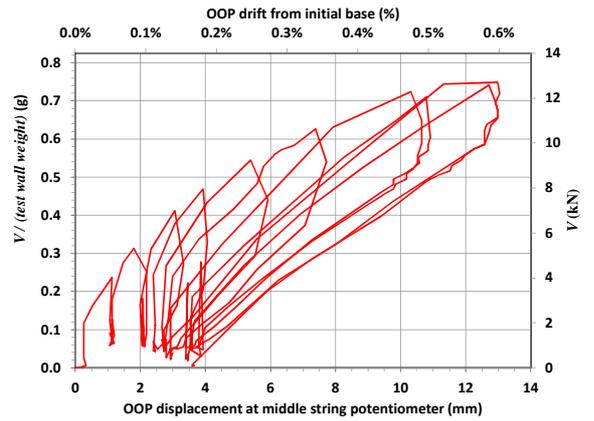
(b) Wel-W2B displacement at S2 (see Figure 17)

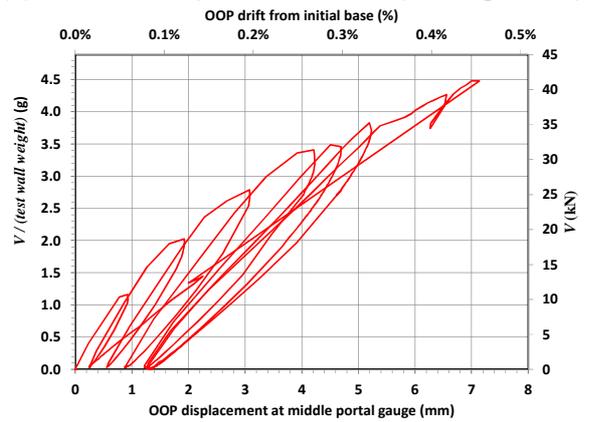
(d) Wel-W4 displacement at G8 (see Figure 17)

- ▶ Walls Wel-W3 and Wel-W4 were each loaded until the capacity of the loading frame or load cell instrumentation was reached. The load-displacement curves in **Figure 29(c)** and **(d)** for walls Wel-W3 and Wel-W4, respectively, appear close to plateauing at the peak loads and are hence considered to finish just short of the peak load capacities of the test walls, although it should be noted that wall Wel-W3 was the only wall tested in vertical flexure in this entire program that was not successfully cracked near mid-height (nor was any other cracking apparent on Wel-W3);

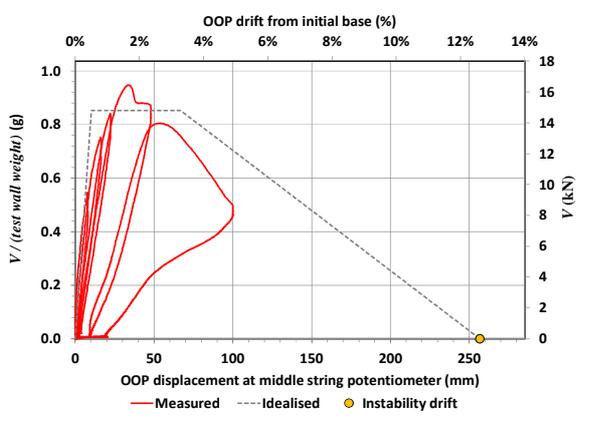
(f) Has-W1 displacement at S2 (see Figure 21)

- ▶ The relative behaviour of test walls Has-W1 – Has-W6 as shown in **Figure 29(f) – (l)** led researchers to conclude the following:
 - Retrofit ties with adequate spacing and shear stiffness can greatly improve the out-of-plane capacity of URM cavity walls. For a force-based analysis, the wall strip strength was approximately doubled from the in situ condition to the condition in which ties were vertically spaced at approximately 150 mm considering the test walls with fixed topside restraints [compare the relative performance of in situ Has-W5 with retrofitted Has-W6 in **Figure 29(l)**]. An even greater improvement in displacement-based performance was observed;

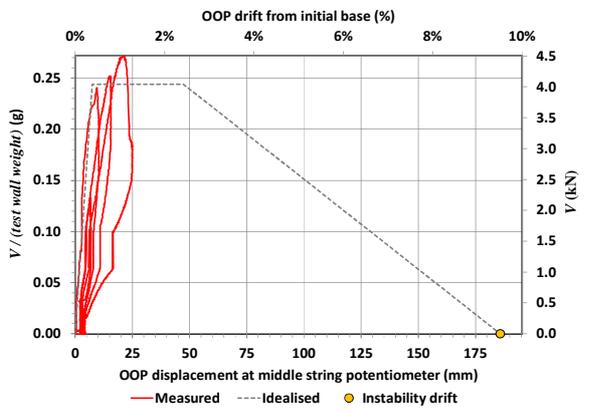
(h) Has-W3 displacement at S2 (see Figure 21)

- In comparison to the results from the test walls in the Auckland CBD building [**Figure 29(m) – (p)**] as well as two other wall panels in Hastings that were propped on the top edge [**Figure 29(h)** and **(i)**], it is clear that top edge fixed restraint condition improves the load capacity of the wall panels significantly; and

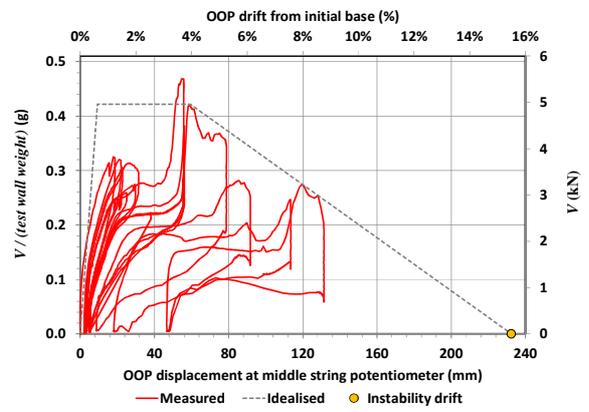
(n) Auc-W1B displacement at S2 (see Figure 23)

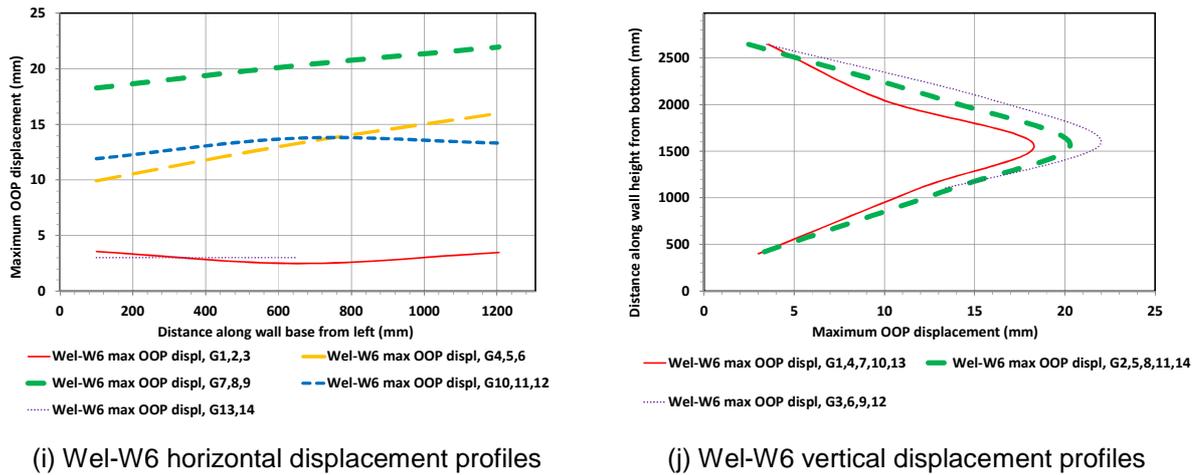
Figure 30: OOP maximum displacement profiles for walls tested in one-way vertical flexure at the WRS building

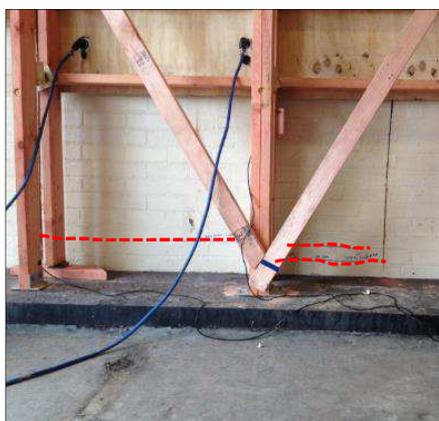
(a) Horizontal crack near the bottom on the loaded side of Wel-W2B (marked for emphasis)

With the exception of Wel-W3, all walls tested in one-way vertical flexure in this program (i.e., those listed in **Table 9**) were loaded until a horizontal crack was formed across the entire length on the instrumentation side of each wall near mid-height. Corresponding to the locations of the maximum bending moments in **Figure 27**, horizontal cracks would initially form on the loaded side of each test wall near the base (and near the top in the case of walls fixed at the top) prior to the horizontal cracks forming near mid-height on the instrumentation side. The location of the horizontal cracks near mid-height also corresponded to the locations of maximum mid-span bending moments shown in **Figure 27** (i.e., cracks formed near one-half height in the case of walls fixed at the top and near five-eighths height in the case of walls propped at the top). The formation of mid-height horizontal cracks indicated that the response of the OOP walls tested in one-way vertical flexure transitioned from behaving as beams to behaving as rocking-wall mechanisms with mid-height hinges (see **Figure 28**). This rocking-wall behaviour forms the basis of the OOP ultimate displacement analysis procedure recommended for URM walls by Derakhshan et al. (2013a, 2014). These cracks closed partially after the load was released in each case. **Figure 31** includes images of typical horizontal cracks observed in this test program. Note that the height of each mid-height crack above the test wall base is an important value for assessment as discussed in **Section 5.1.4**.

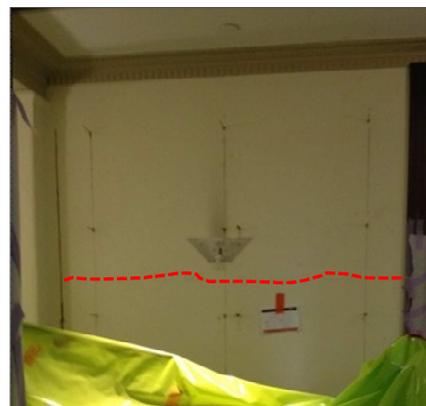
(b) Horizontal crack near one-half height on the instrumentation side of Wel-W4 (marked for emphasis)

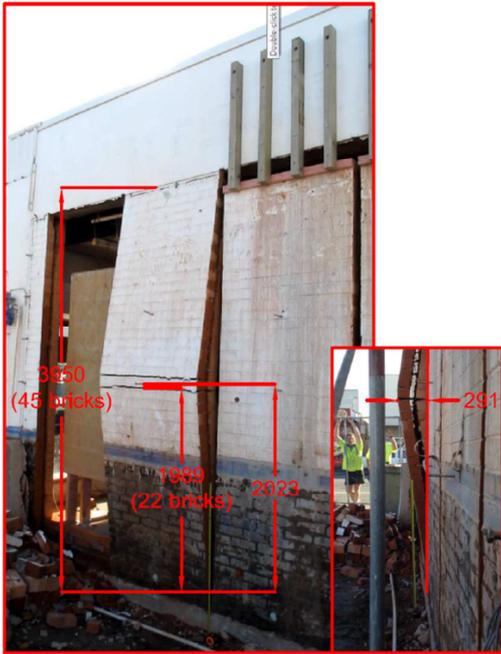
(c) Horizontal crack near one-half height on the instrumentation side of Has-W2 (example of use of photogrammetry to determine instability drift)

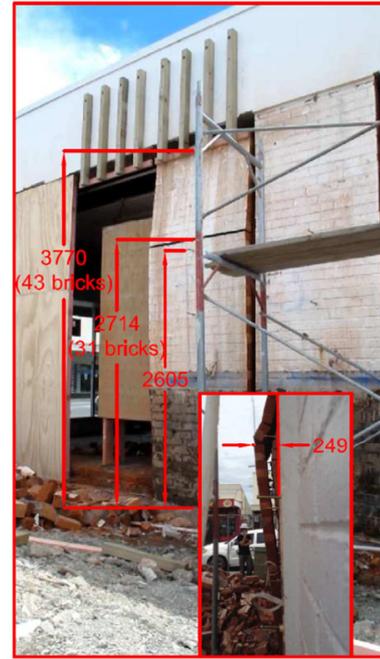
(d) Horizontal crack near five-eighths height on the instrumentation side of Has-W4 (example of use of photogrammetry to determine instability drift)

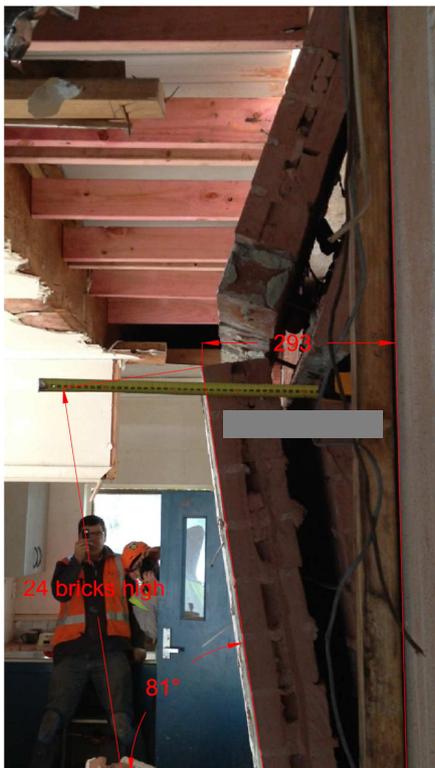
(e) Horizontal crack near five-eighths height on the instrumentation side of Auc-W1B (example of use of photogrammetry to determine instability drift)

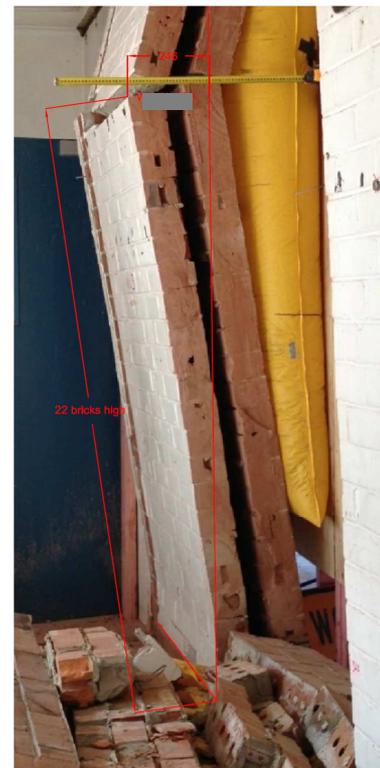
(f) Horizontal crack near five-eighths height on the instrumentation side of Auc-W3 (example of use of photogrammetry to determine instability drift)

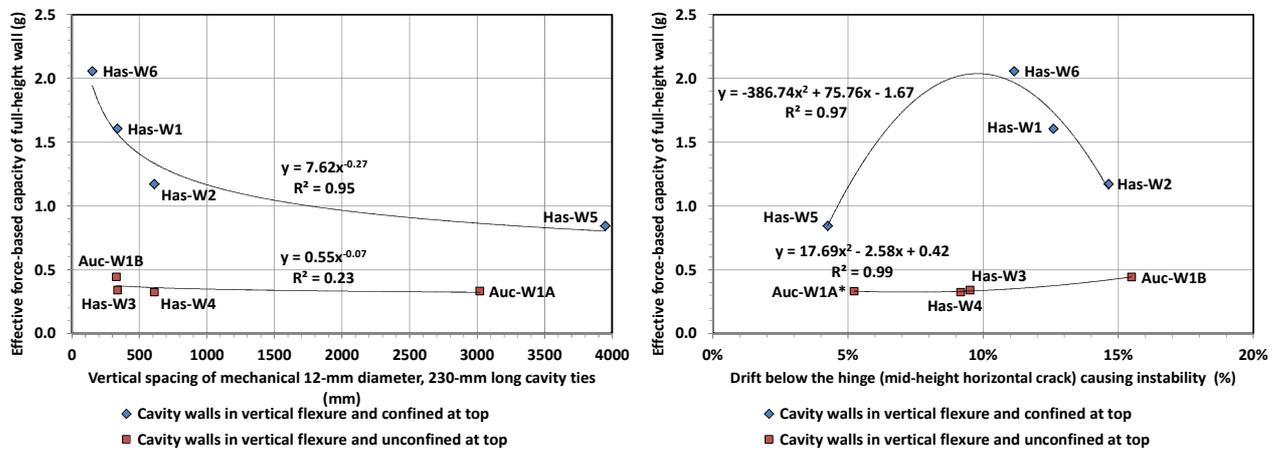
(a) Vertical spacing of cavity ties (mm) versus effective capacity (g) with trend lines

Considering that the walls tested in one-way vertical flexure at the Hastings and Auckland CBD buildings were similar in geometry (length and two-leaf thickness with a cavity), various trends are charted in **Figure 32** considering the cavity tie spacings listed in **Table 9**, the instability drifts charted in **Figure 29**, and the effective force-based capacities listed in **Table 10**. Note that test walls Has-W3 and Auc-W1B had the same cavity ties installed at the same vertical spacing, as well as propped top conditions. Because test wall Has-W3 was thicker (see **Table 9**), test wall Auc-W1B benefitted from stronger material properties in order to be loaded to both a higher capacity and instability drift than Has-W3 (see **Section 3.1**).

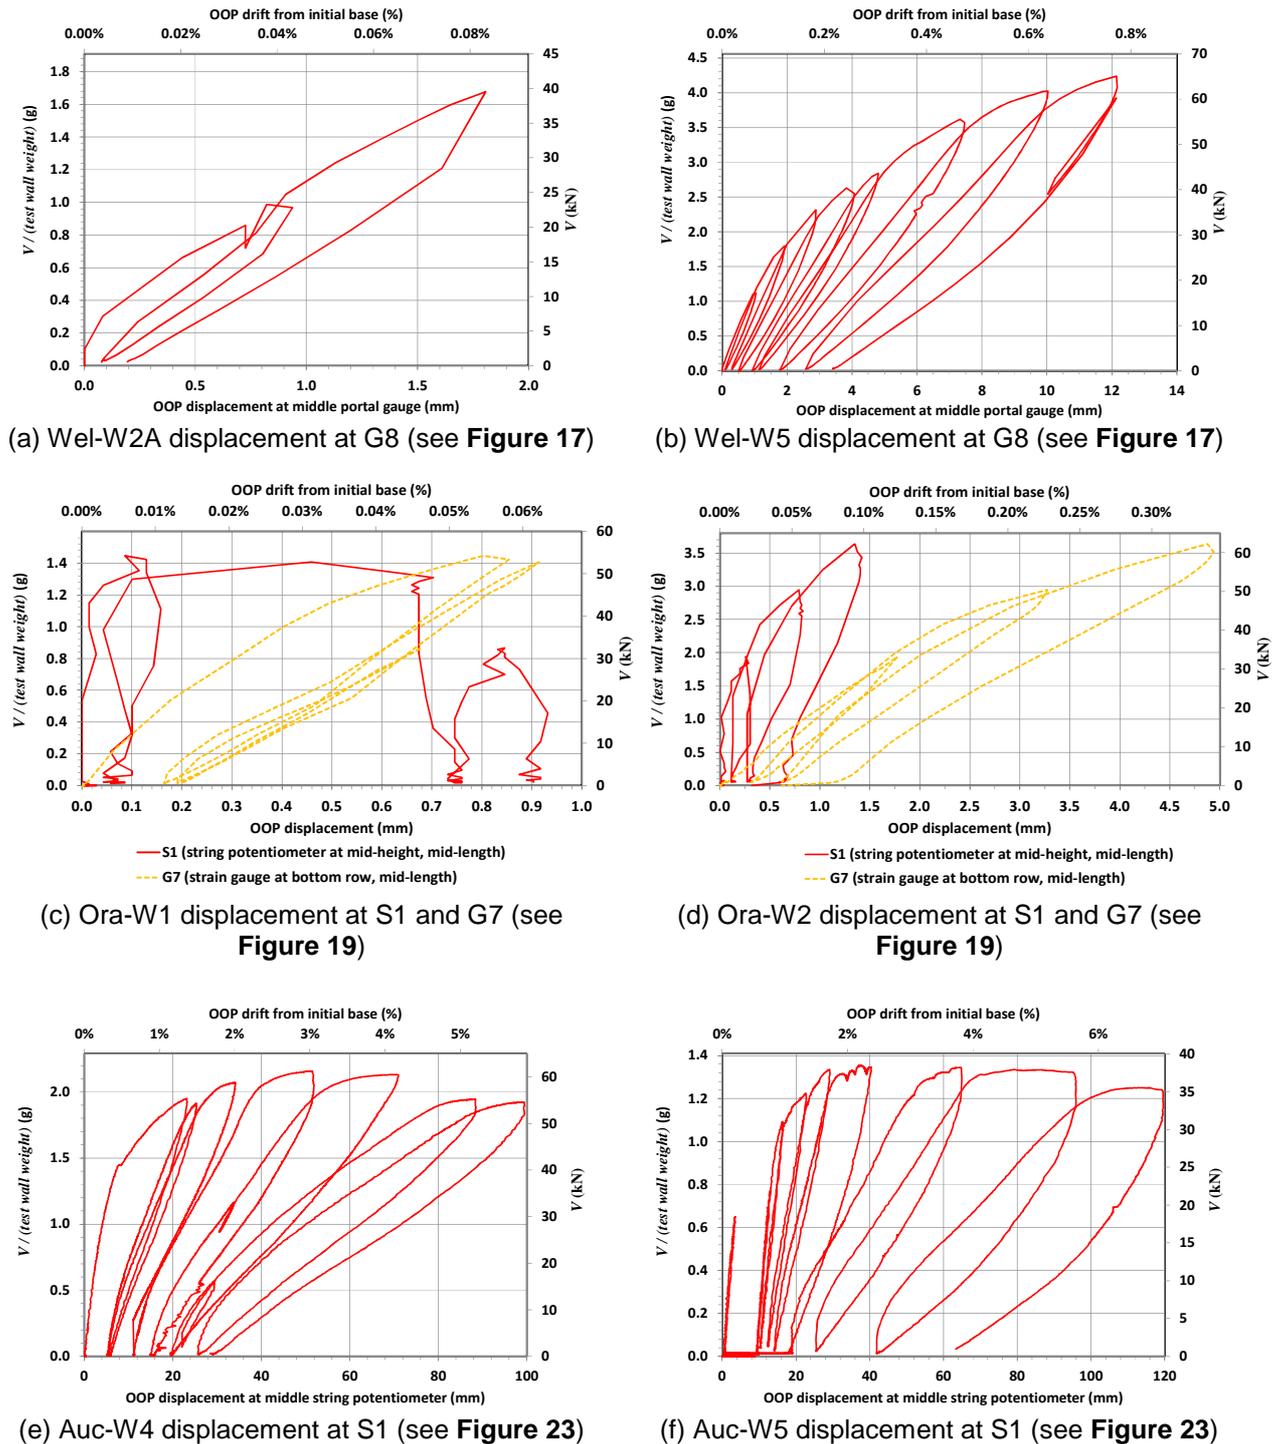
Figure 33: Load-displacement responses for walls tested in two-way flexure

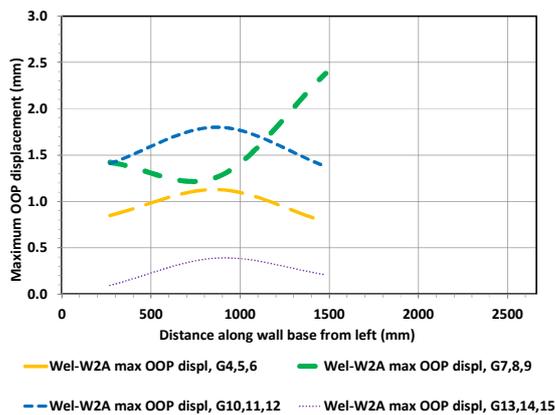
(a) Wel-W2A horizontal displacement profiles

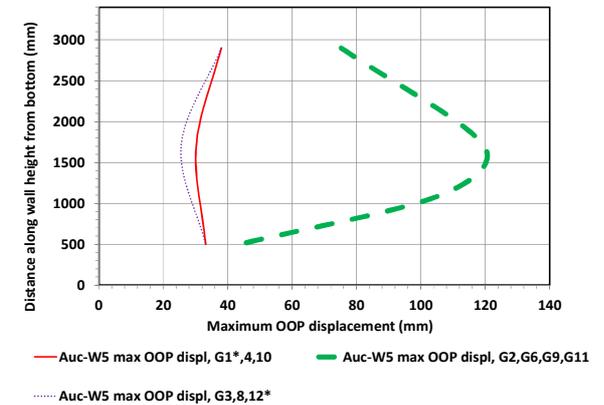
(l) Auc-W5 vertical displacement profiles
(* indicates estimated displacement)

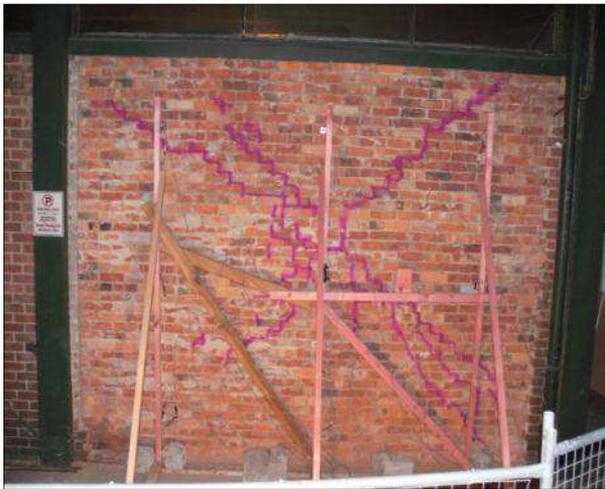
(a) Crack pattern post-loading on the instrumentation side of Auc-W4

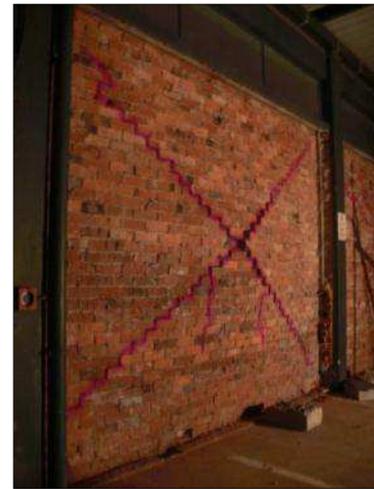
(b) Crack pattern post partial loading on the instrumentation side of Auc-W5

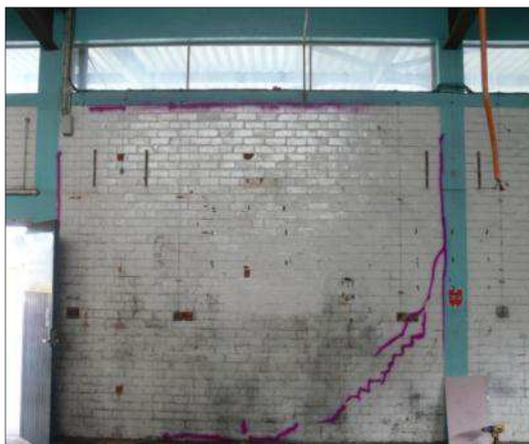
(c) Crack pattern post-loading on the loading side of Auc-W4

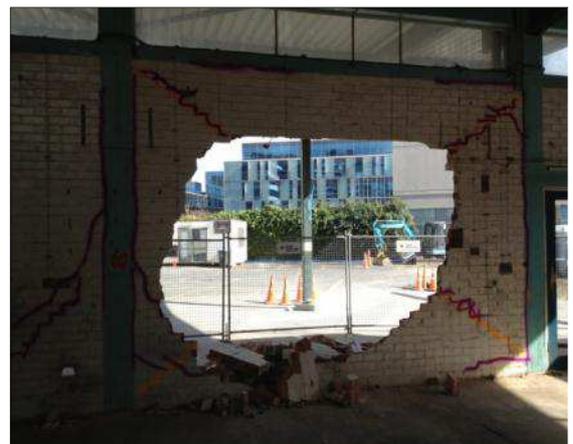
(d) Partial wall collapse post-loading on the loading side of Auc-W5
